TITLE: UNDERWRITERS LABORATORIES FIRE TESTS OF
SPRAYED POLYURETHANE FOAM APPLIED
DIRECTLY TO METAL ROOF DECKS

AUTHOR: R. L. Alumbaugh and S. R. Conklin

DATE: December 1983

NAVAL CIVIL ENGINEERING LABORATORY
PORT HUENEME, CALIFORNIA 93043

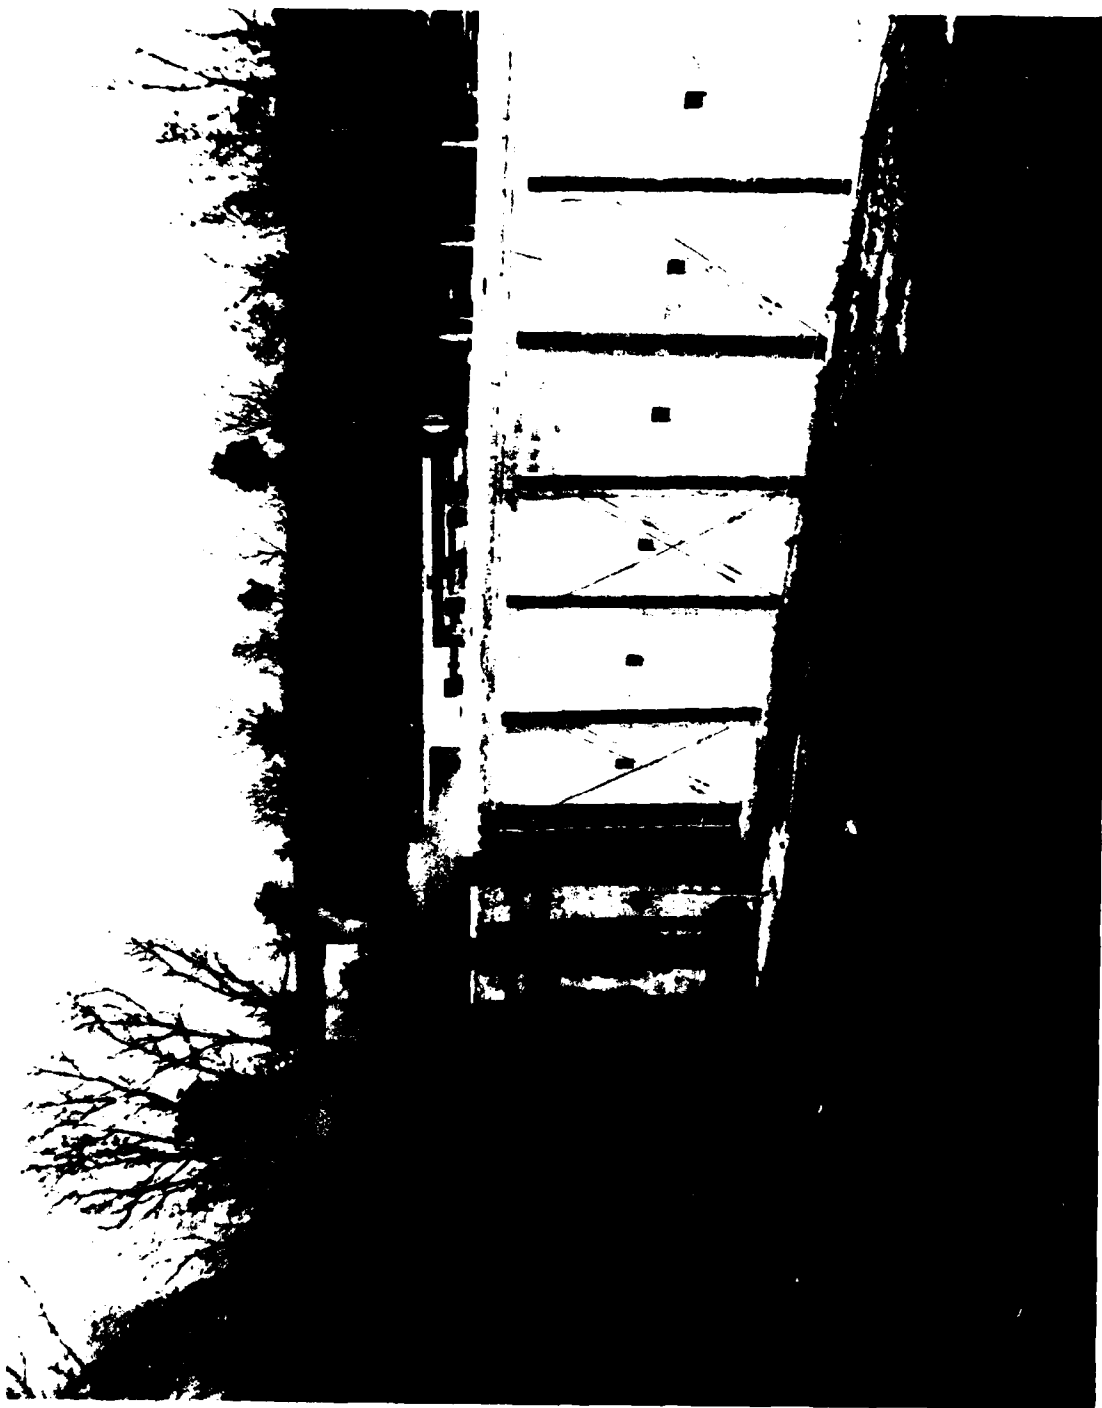
Figure 1. Exterior view of White House structure showing roof during the test.

Three minutes after heptane ignition, light smoke was emitted from the exterior roof edges along the perimeter of the fire end. Figure 1 shows the exterior of the roof during the test burn. After 4 minutes, smoke began issuing from the joints in the underside of the roof, becoming very dense after 8 minutes. This obscured vision of the burners from the flue end; however, smoke had cleared within the structure after 11-1/2 minutes. The density of the smoke fluctuated but did not again obscure vision within the structure. Figure 2 shows the burners from the flue end 5 minutes after initiation of the test, while Figure 3 gives the same view about 20 minutes after test initiation. Note the lack of smoke inside the White House. It is understood that when testing a conventional or standard built-up roof (BUR) assembly, dense smoke fills the interior of the White House after 4 to 7 minutes, and the density remains constant thereafter until the end of the 30-minute test period; i.e., the very dense smoke does not clear as it did with the foam roof.
